Gear Changing without Operator Action T-180

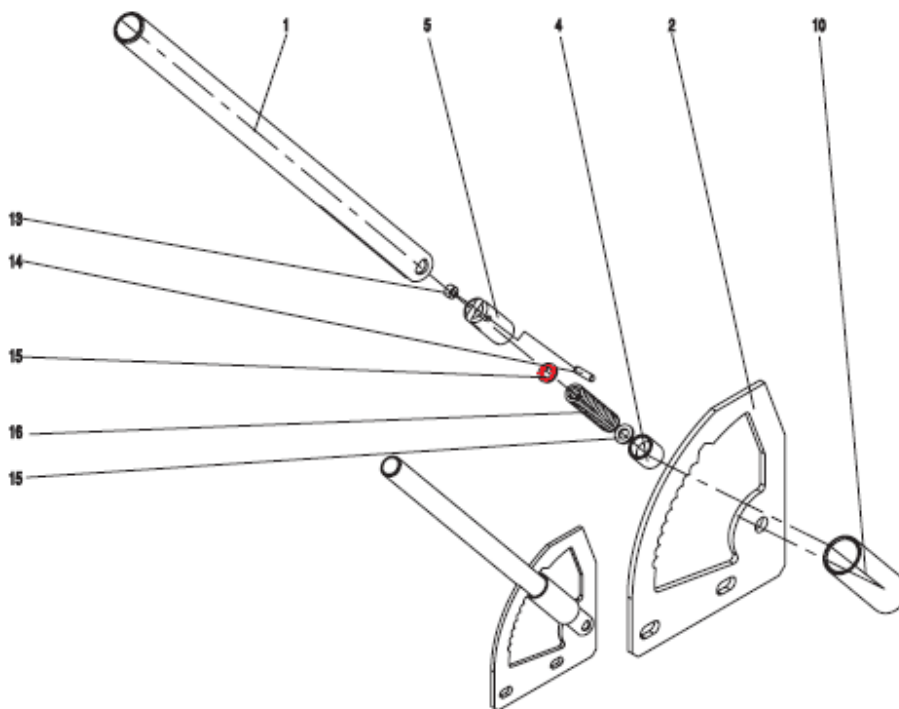
Automatic gear "up shifting" can occasionally occur when there is insufficient tension on the gear change ratchet spring.

The addition of one or more shims (2mm to 4mm of washers) above the spring in the handle mechanism should stop this occurring.

Careful removal of the complete assembly is required before dismantling to install the additional shims. As a spring is part of the mechanism care needs to be taken to avoid an "explosive" release of the spring and associated loss of parts that may have flown off to unknown points of the workshop.

NOTE: If there is too much tension (to many shims) it can make shifting very difficult so it may be that you have to remove a shim, re assemble and test, possibly making shim changes several times until you find the best level of ratchet tension. **Difficulty in shifting can also be from lack of lubrication on the whole gear shift mechanism. See MM no 17**
